CONSTRUCTION STORMWATER GENERAL PERMIT INSPECTION REPORT

State of Washington Department of Ecology

Ecology Inspector(s): Carol Serdar	On-Site Representative Name: Thom Fischer Title: Electron Hydro LLC, permittee	Inspection Date and Entry/Exit Time: 21 Sept 2020, 9:00/14:00	Inspection Type: ERTS and CSWGP review
Contaminated CSWGP Inspector Phone: 360.742.9751 Email: carolserdar@ecy.wa.gov	Additional Participants:	Receiving waters: Puyallup River	Permit webpage: https://fortress.wa.gov/ecy/p/aris/FacilitySummary.aspx?FacilityId=70091

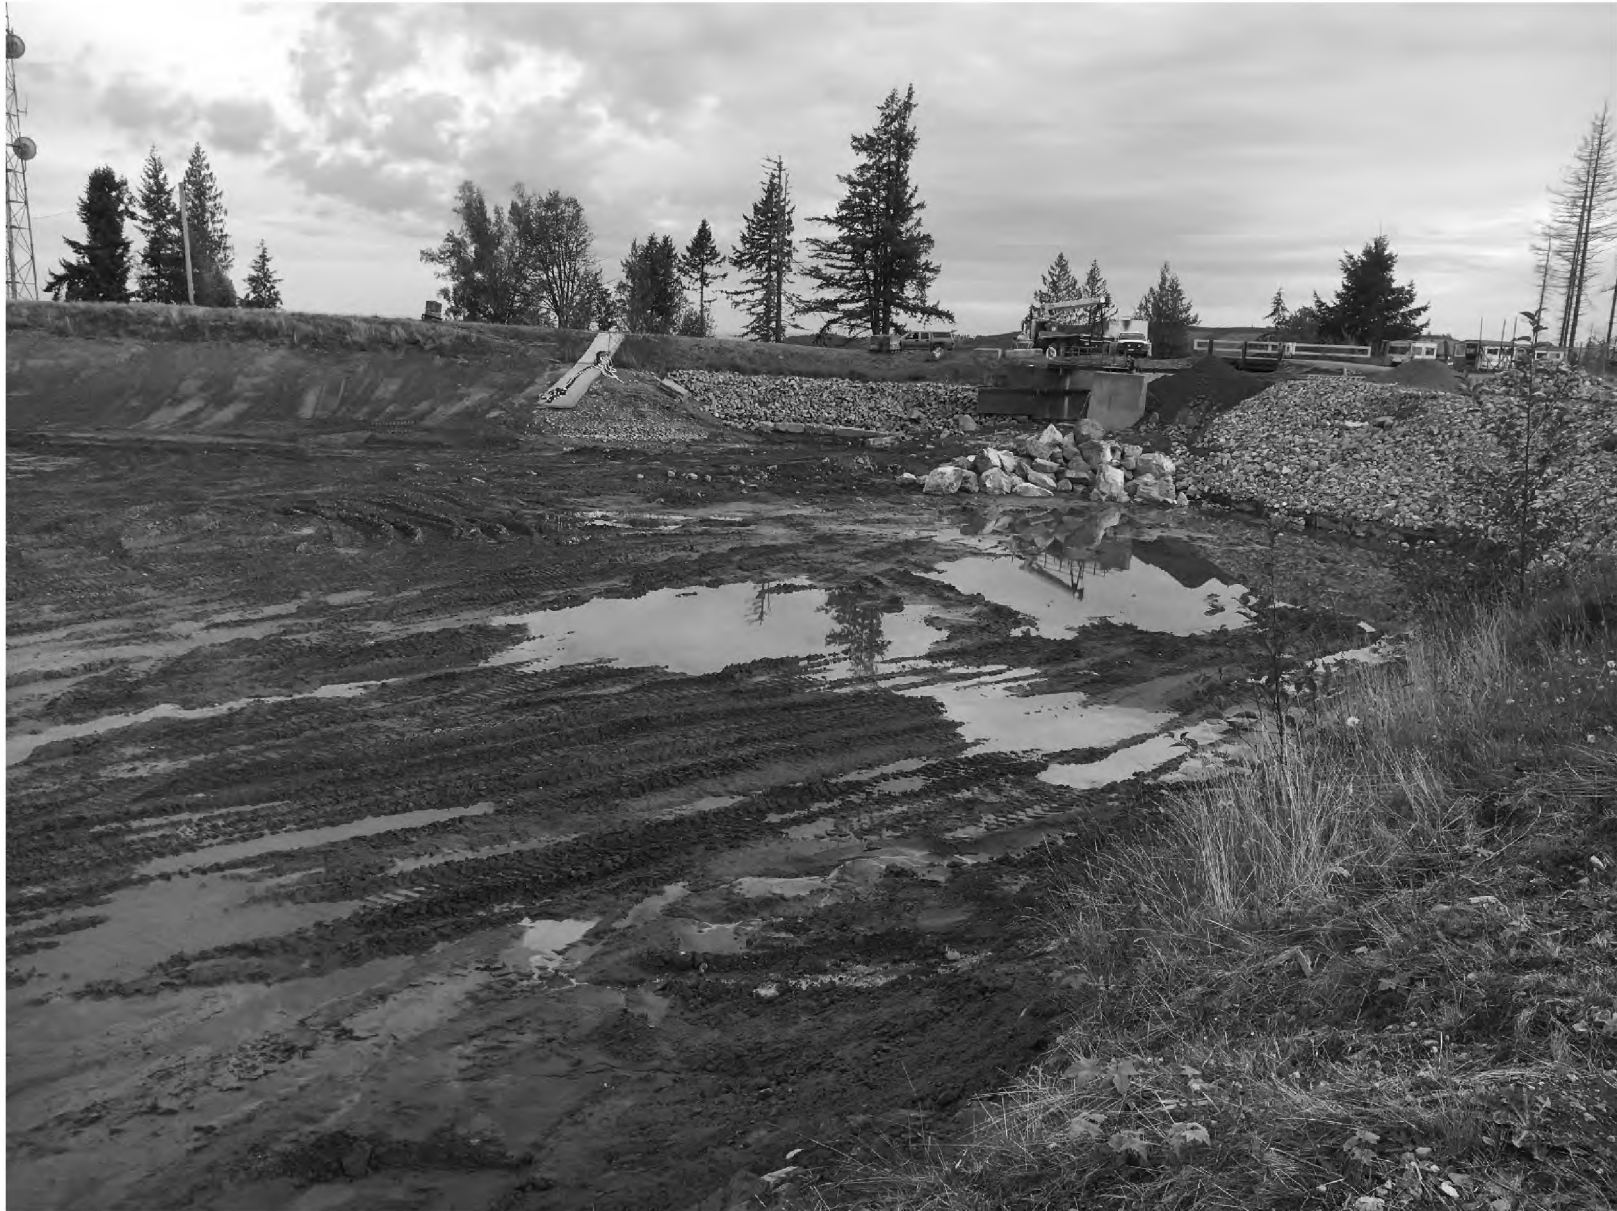
Photo 1

Photo Description: Forebay area – flume enters forebay at the right, behind large rocks.

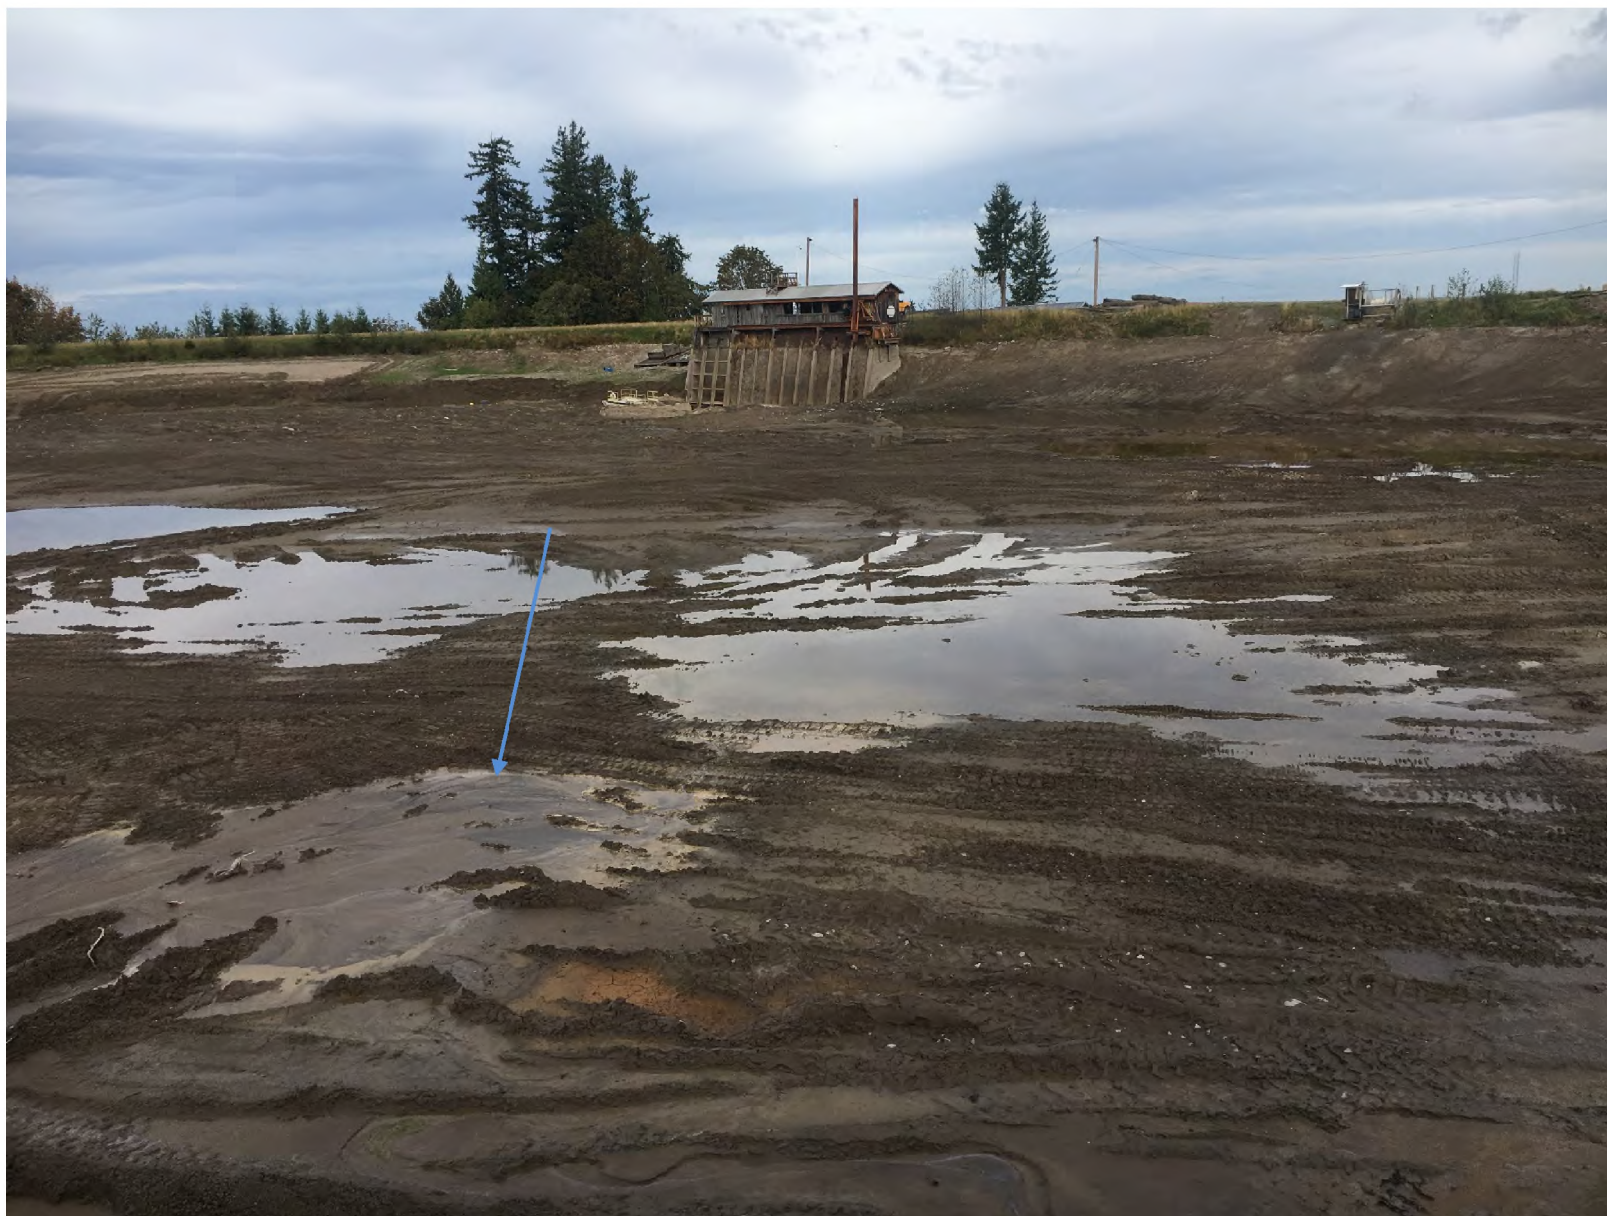
Photo 2

Photo Description: Forebay area – forebay, recent rain added more fines.

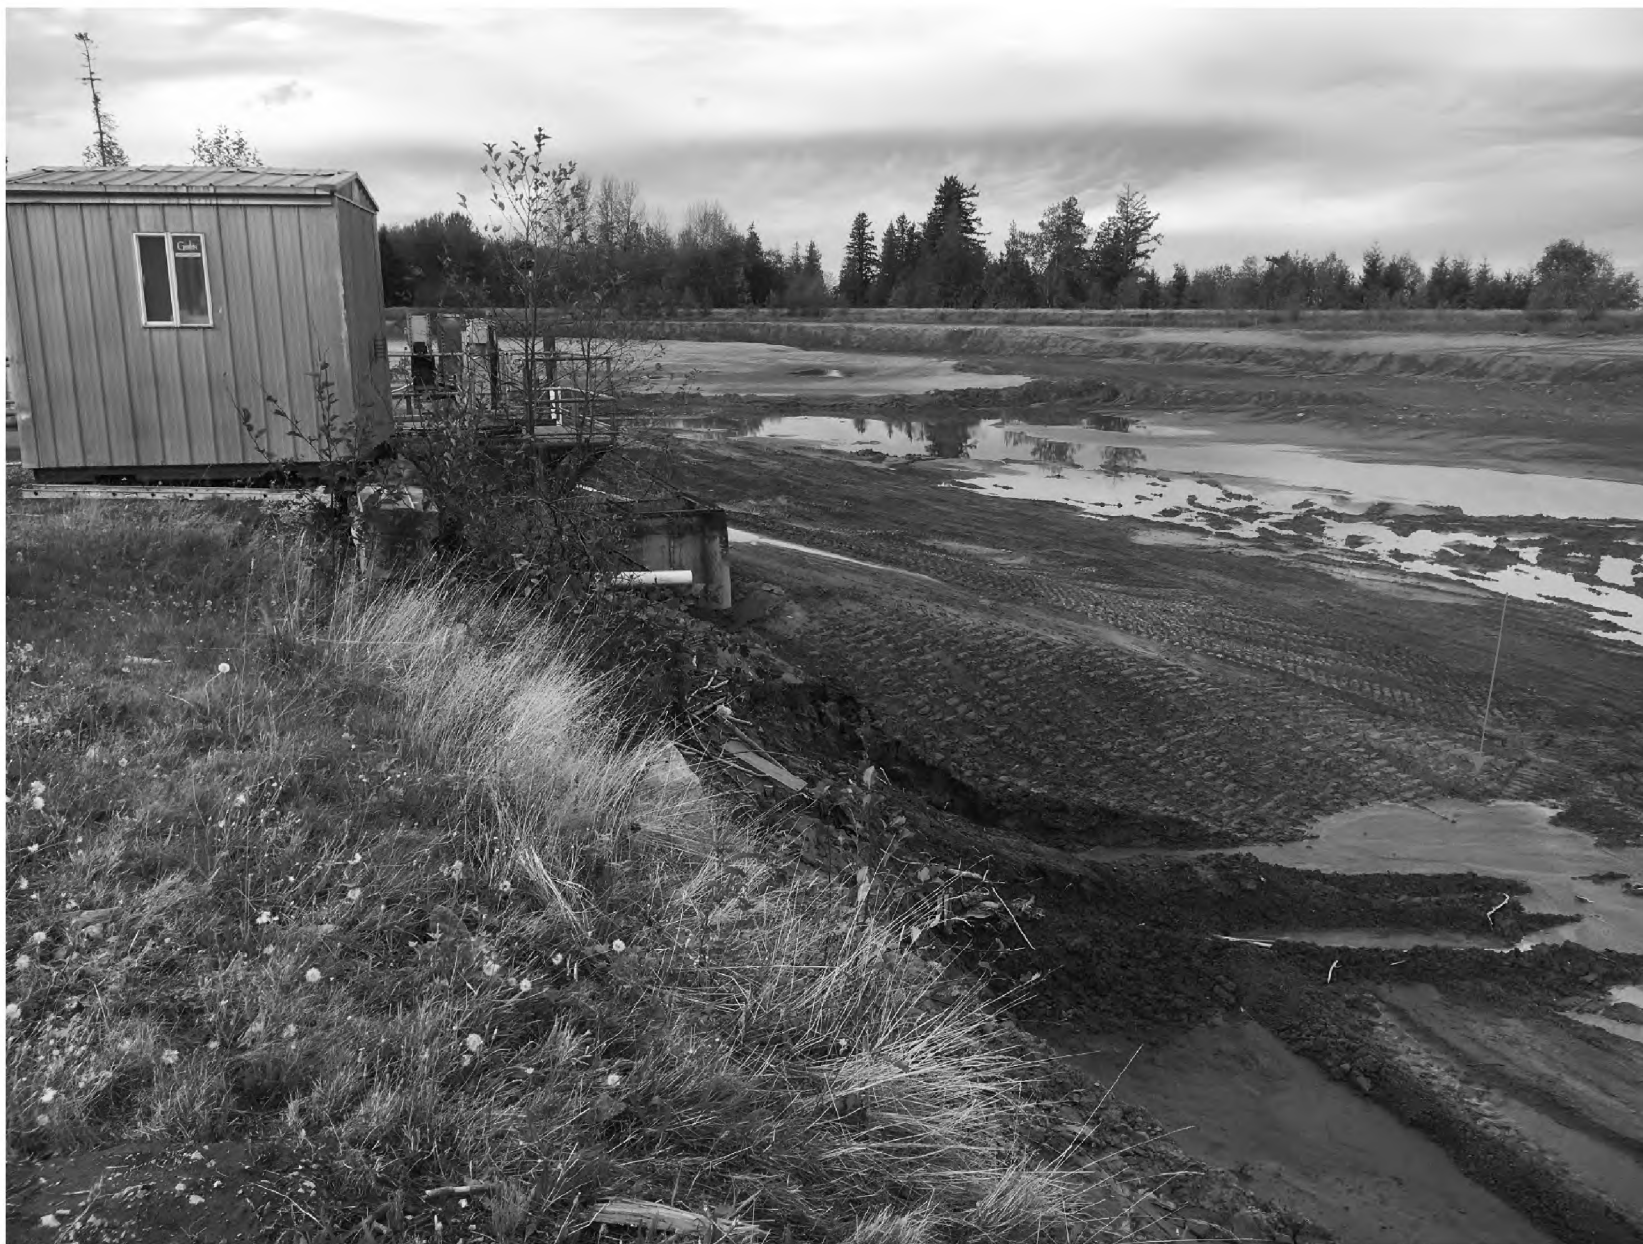
Photo 3

Photo Description: Forebay area – forebay, recent rain added more fines; fish collection facility on left of photo.

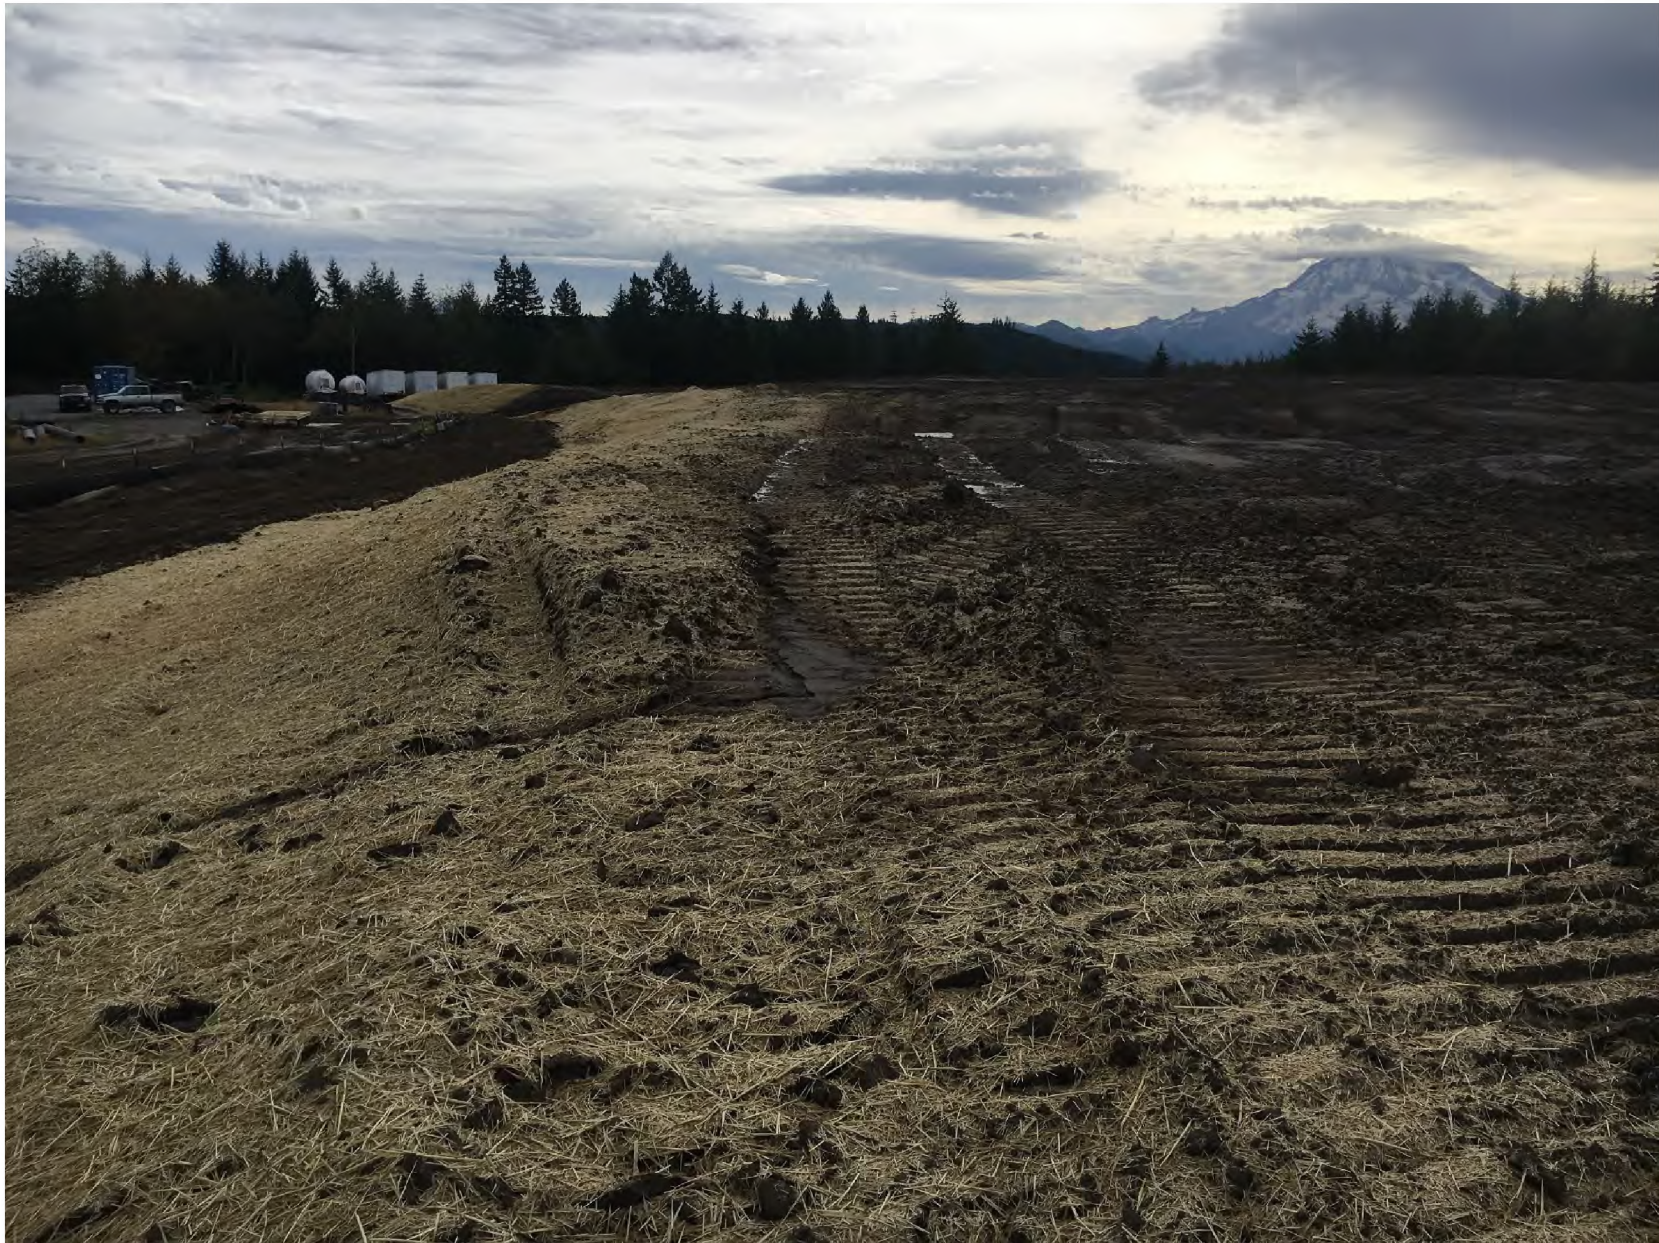
Photo 5

Excavation of sediment from forebay appears to be 15-20 feet thick in some areas of removal; sediment composition is very fine clay. The material is stockpiled in an area adjacent to the maintenance yard at the forebay. Jerry, an Electron employee, met up with Thom and Carol and walked around the stockpile of sediment removed from the forebay. Straw has been applied (some areas need more) to the side slopes of the stockpile; discussed SWMMWW BMP specifics and seeding should be applied now as well as on the top of stockpile. There was no discharge from the area with the stockpile. Area around the stockpile has been clearcut for placement of additional fines. Thom explained this is the same practice PSE was using when he purchased the Project in November 2014.

Photo Description: Forebay area – fine sediment excavated from the dewatered forebay and stockpiled near the forebay.

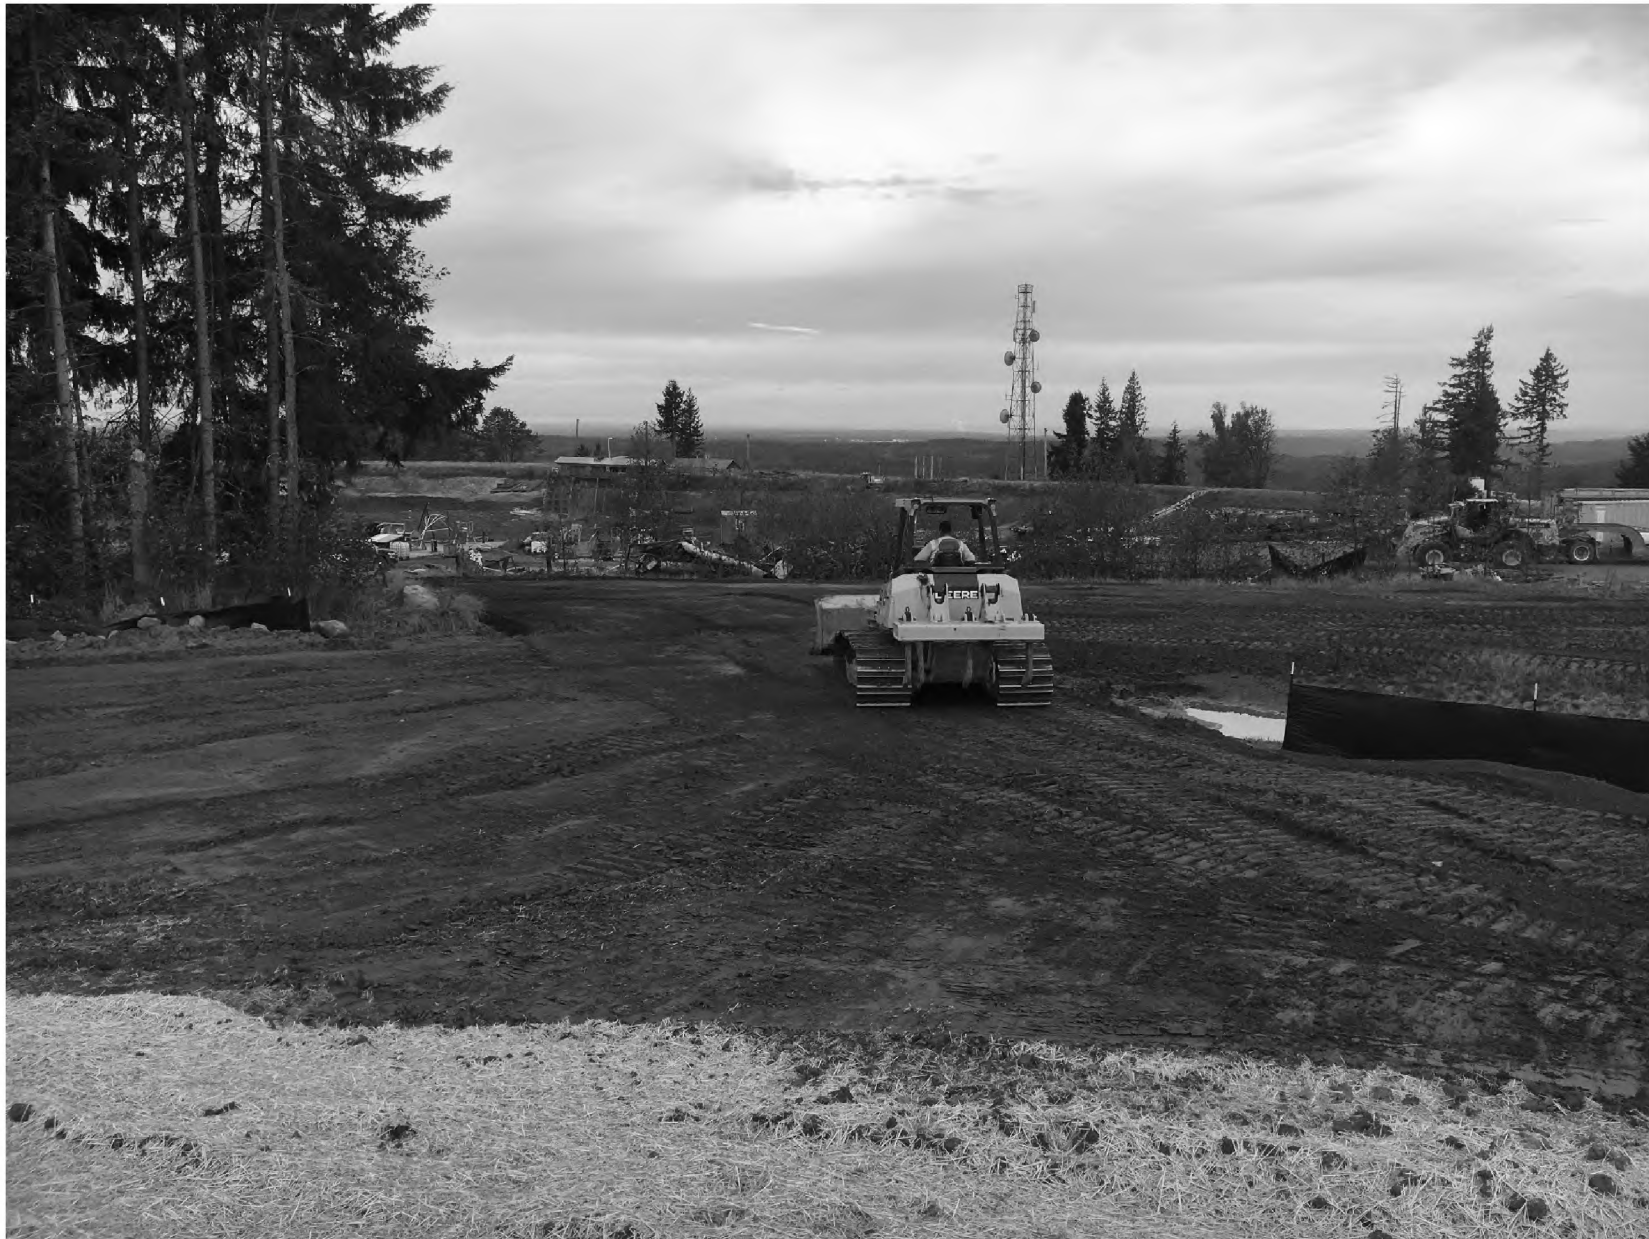
Photo 6

Photo Description: Forebay area – fine sediment stockpiled, forebay located in front of the satellite tower in mid-photo.

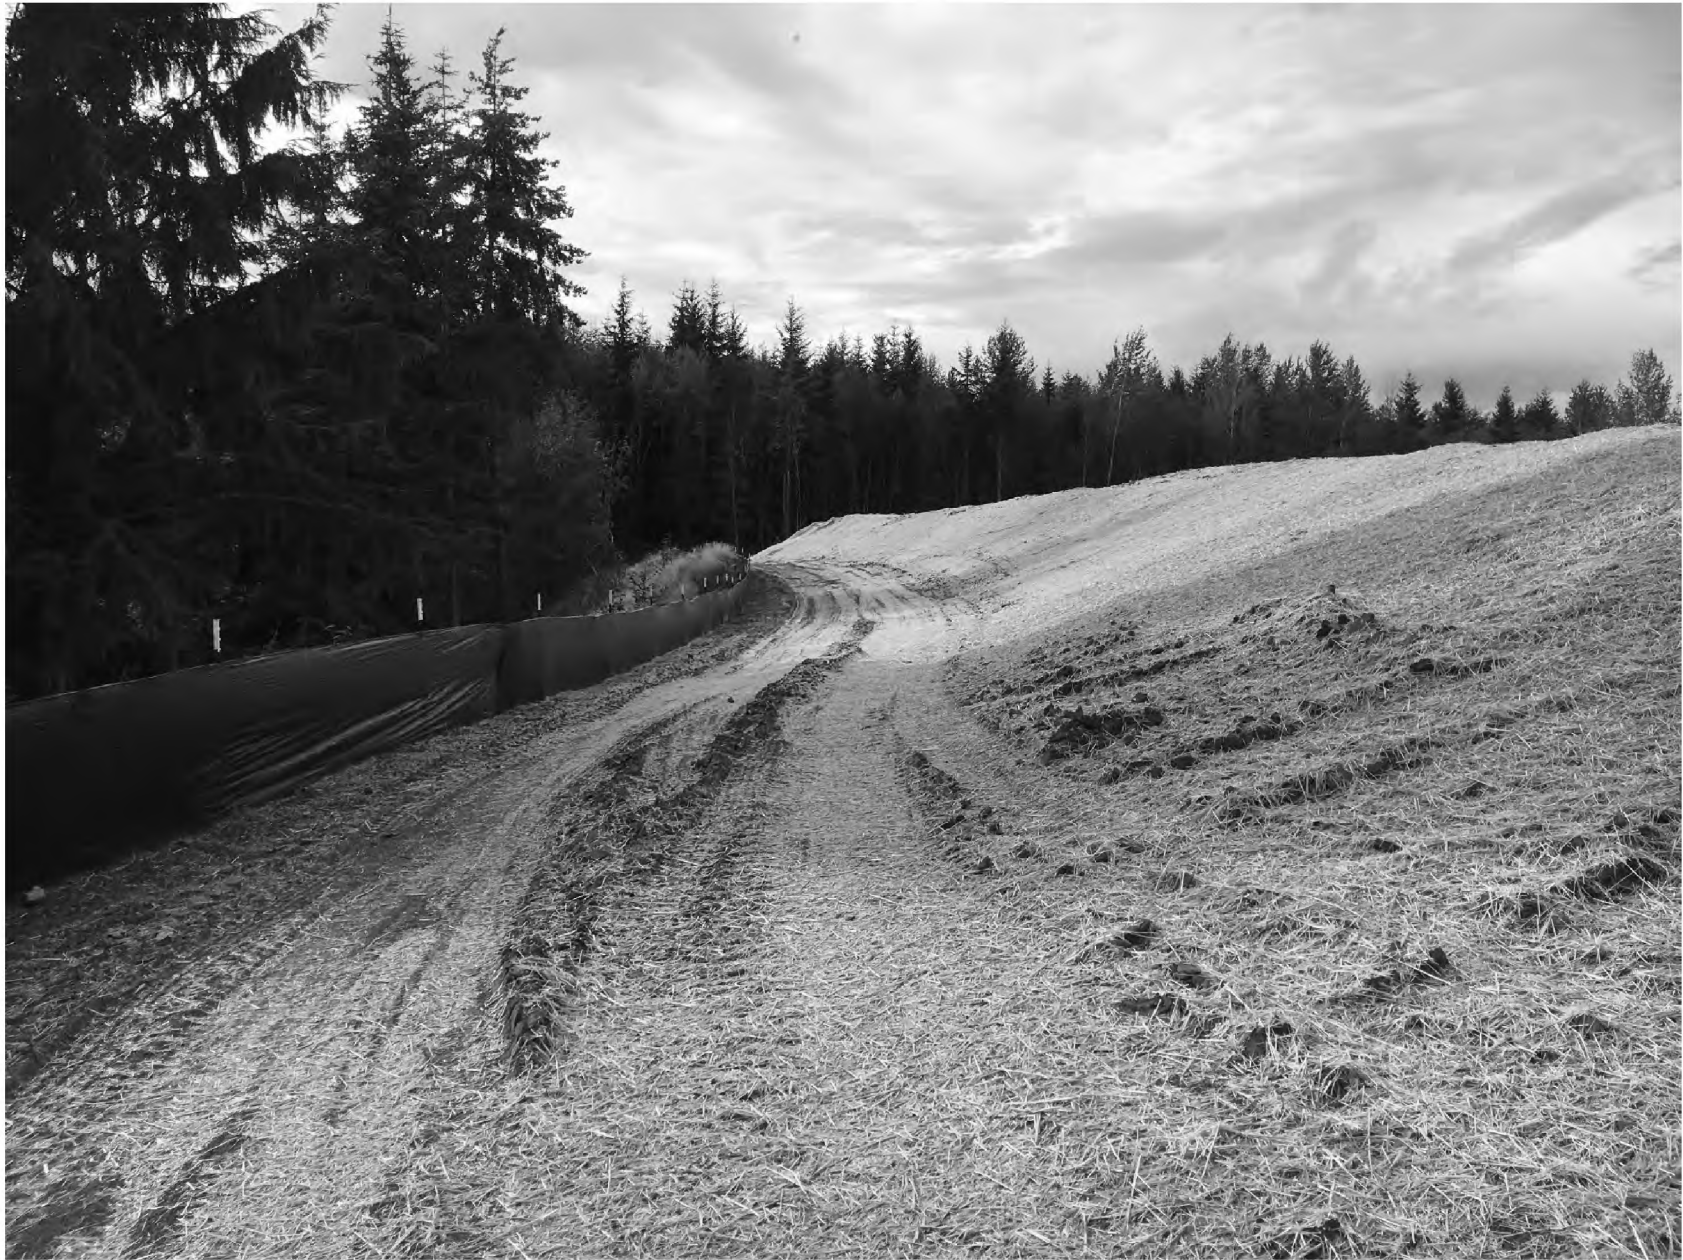
Photo 7

Photo Description: Forebay area – fine sediment stockpiled and straw had been applied; some areas need additional straw.

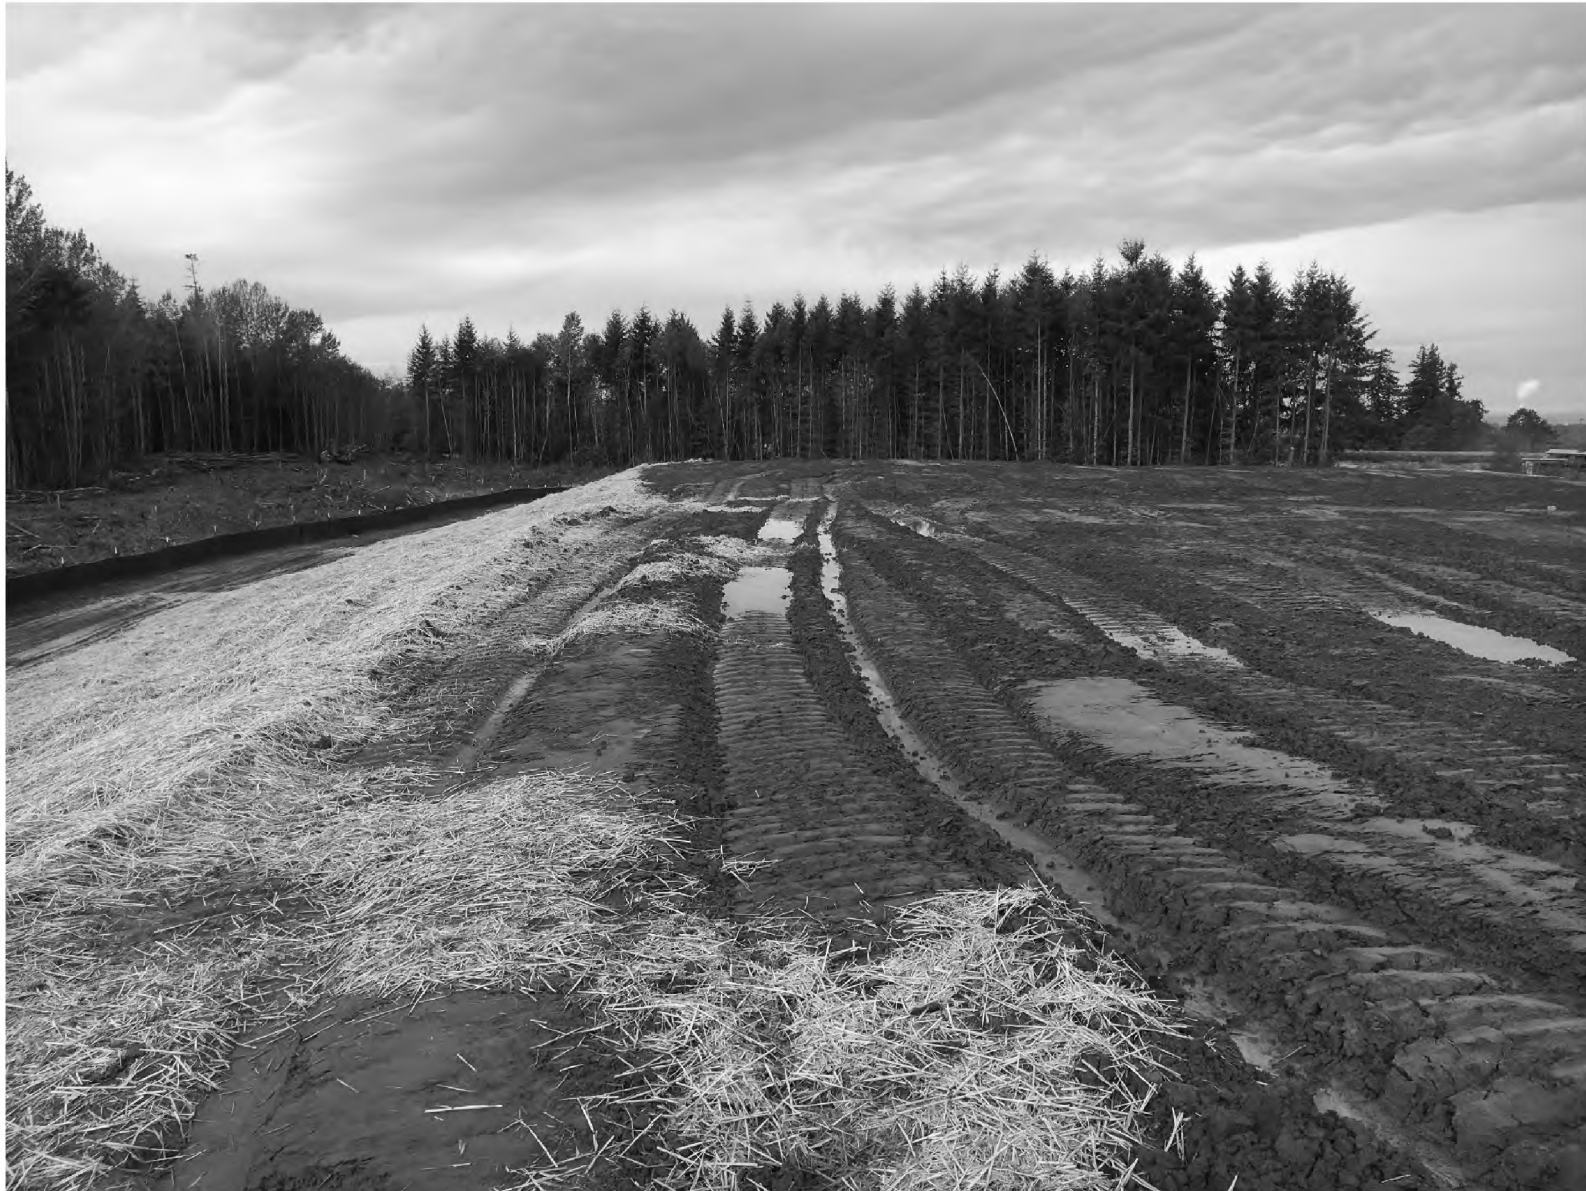
Photo 8

Photo Description: Forebay area – fine sediment stockpiled; no discharge from stockpile area was observed.

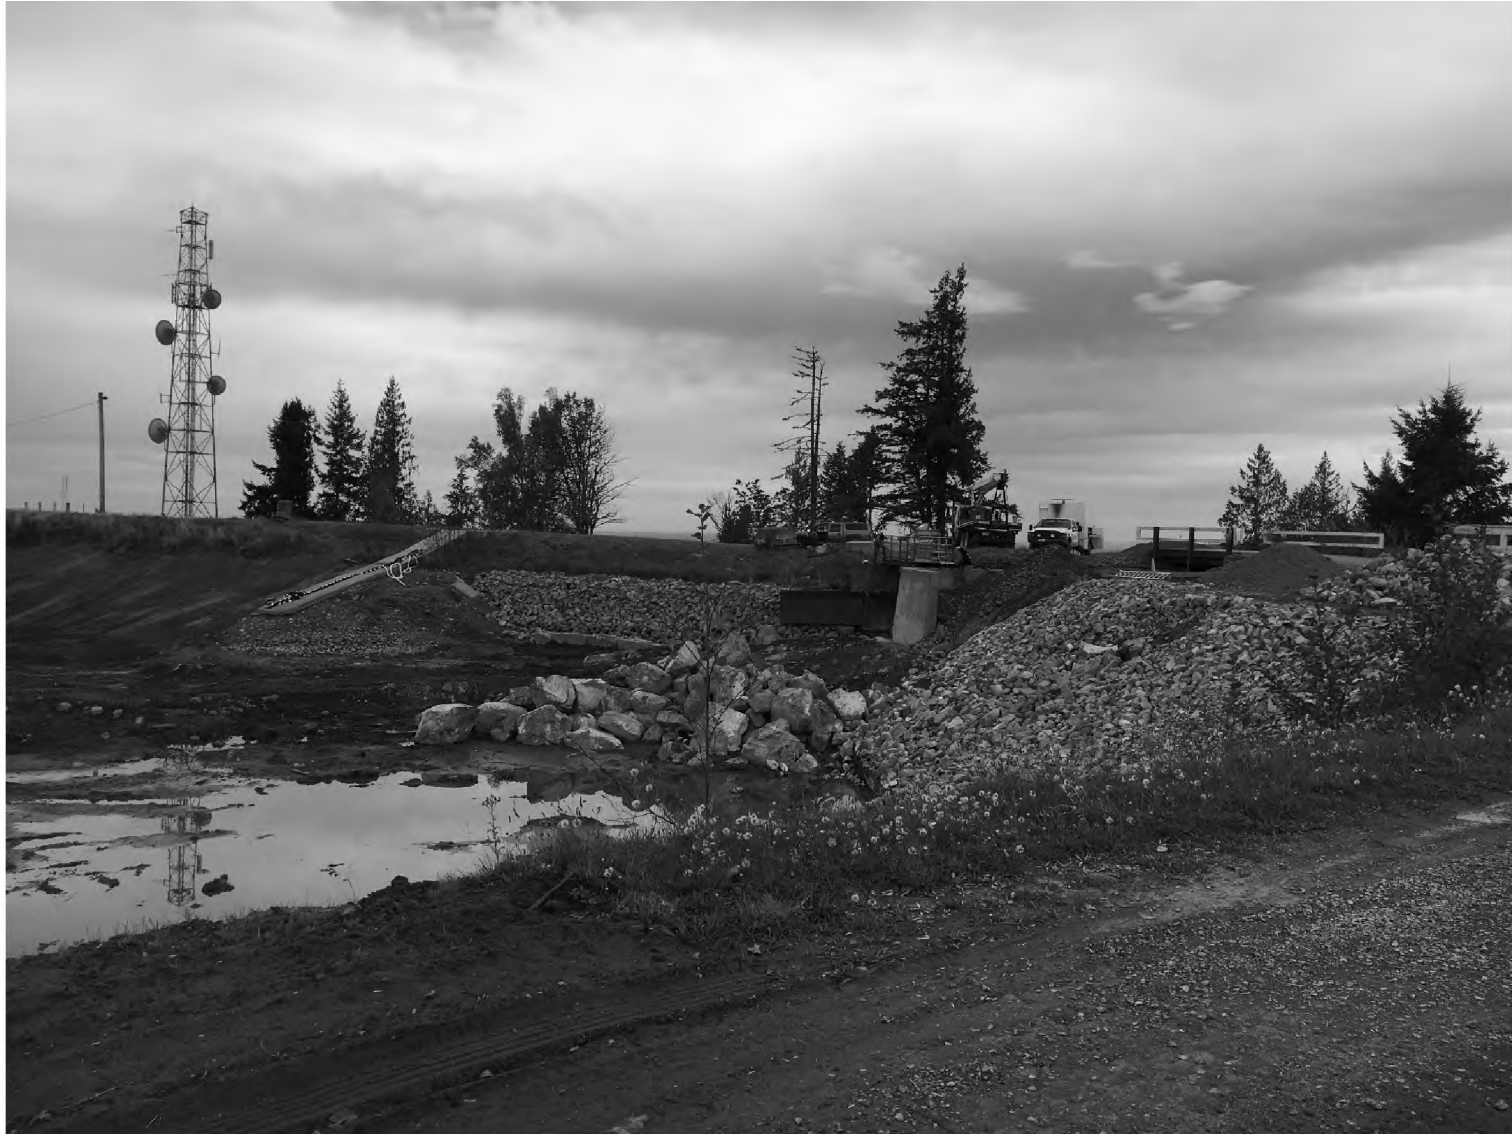
Photo 9

Photo Description: Forebay area – construction of flume entrance into forebay behind large rocks.

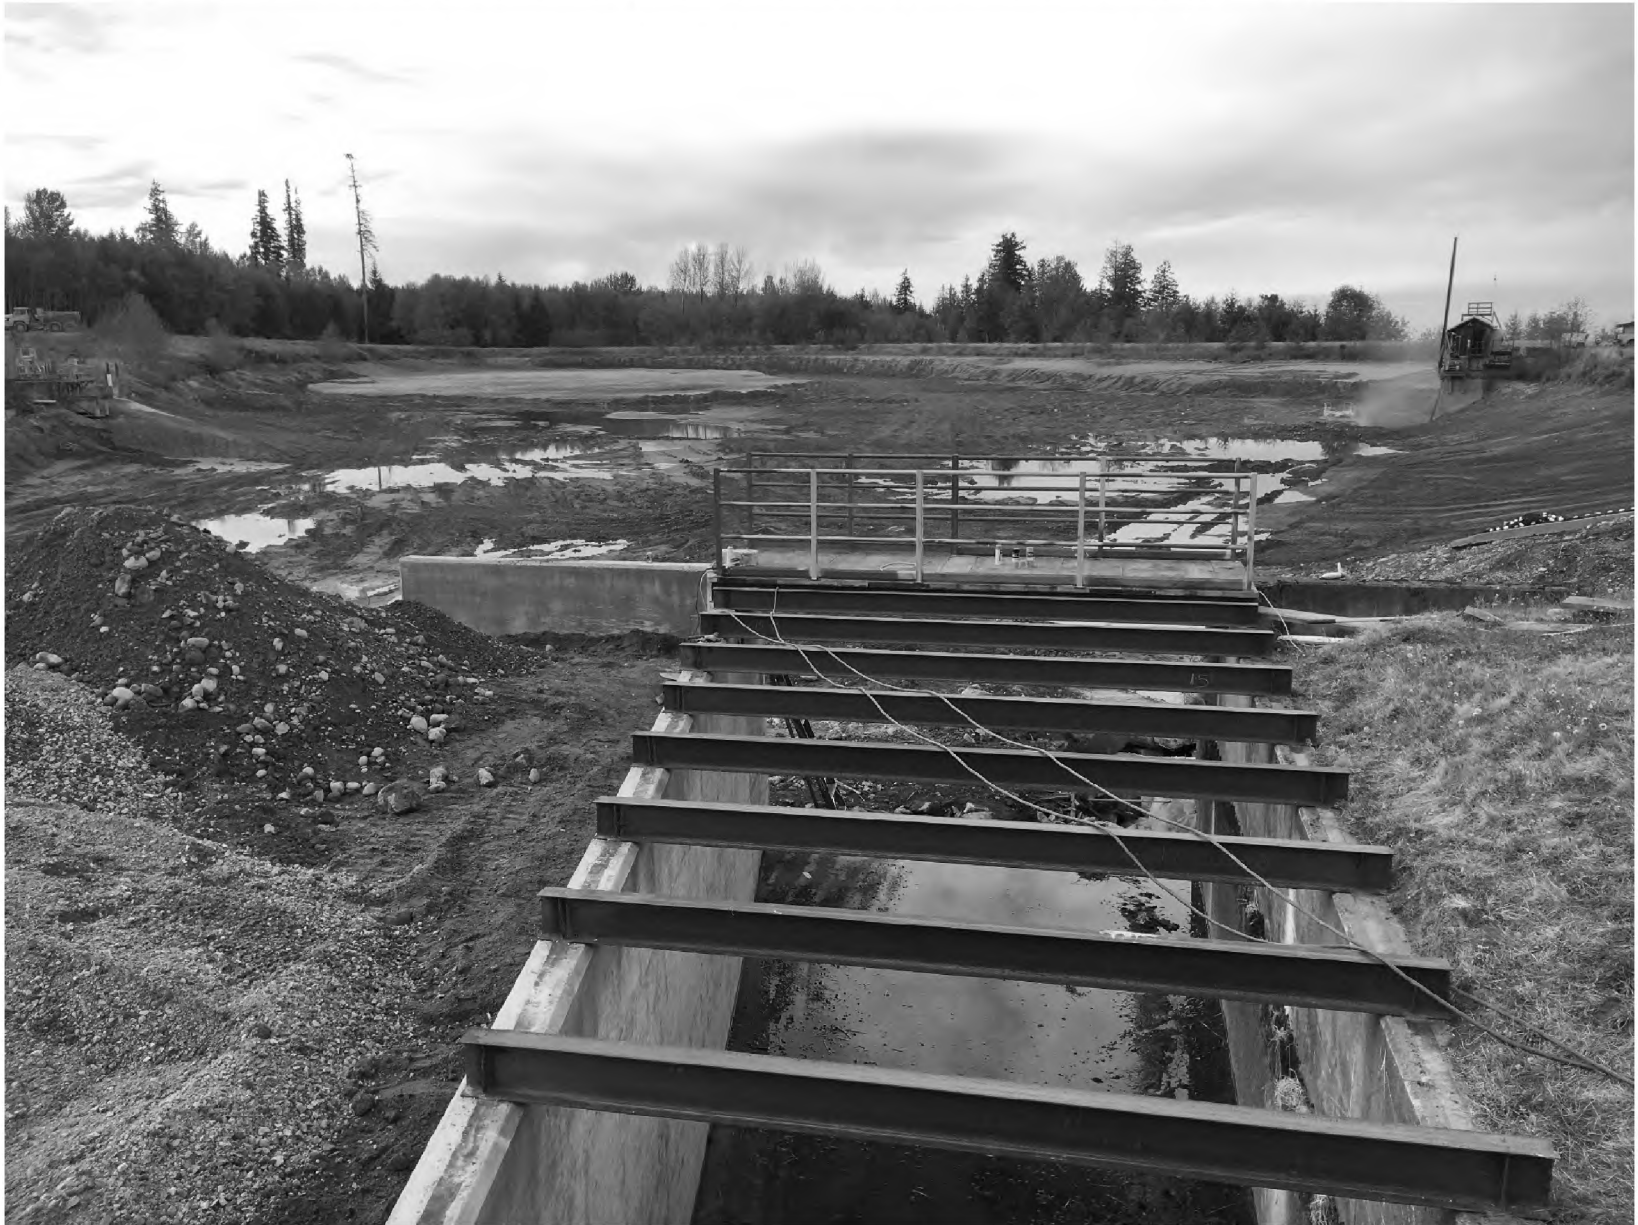
Photo 10

Current work was being performed at the entrance to the forebay; flume connection to the forebay has been widened to direct flow of water toward the fish collection area. Entrance to the penstocks (concrete basin) was being cleaned out. (Unsure where water goes from this cleaning)

Photo Description: Forebay area – flume under construction, widening to change flow into forebay. A portion of the fish collection facility is on left side of photo.

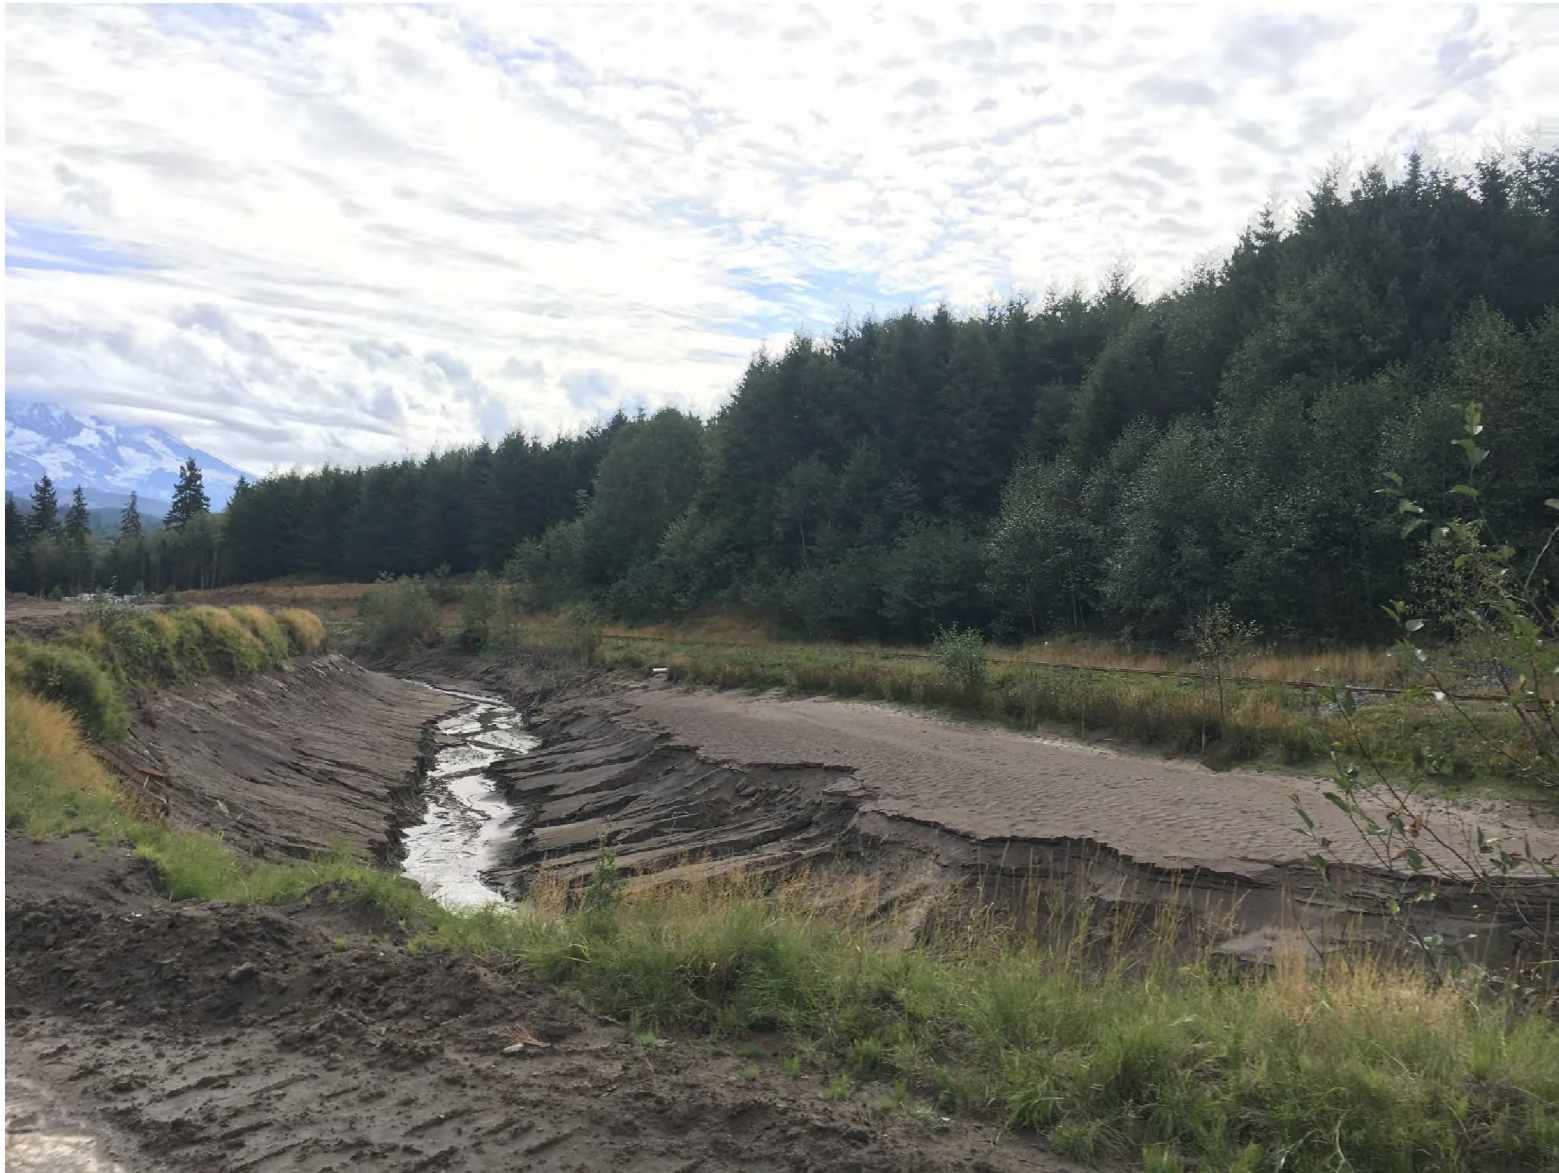
Photo 11

Photo Description: Settling Basin area – settling basin has accumulated sediment on left bank (water would be flowing toward bottom of photo, right bank had been excavated and filled adjacent to basin).

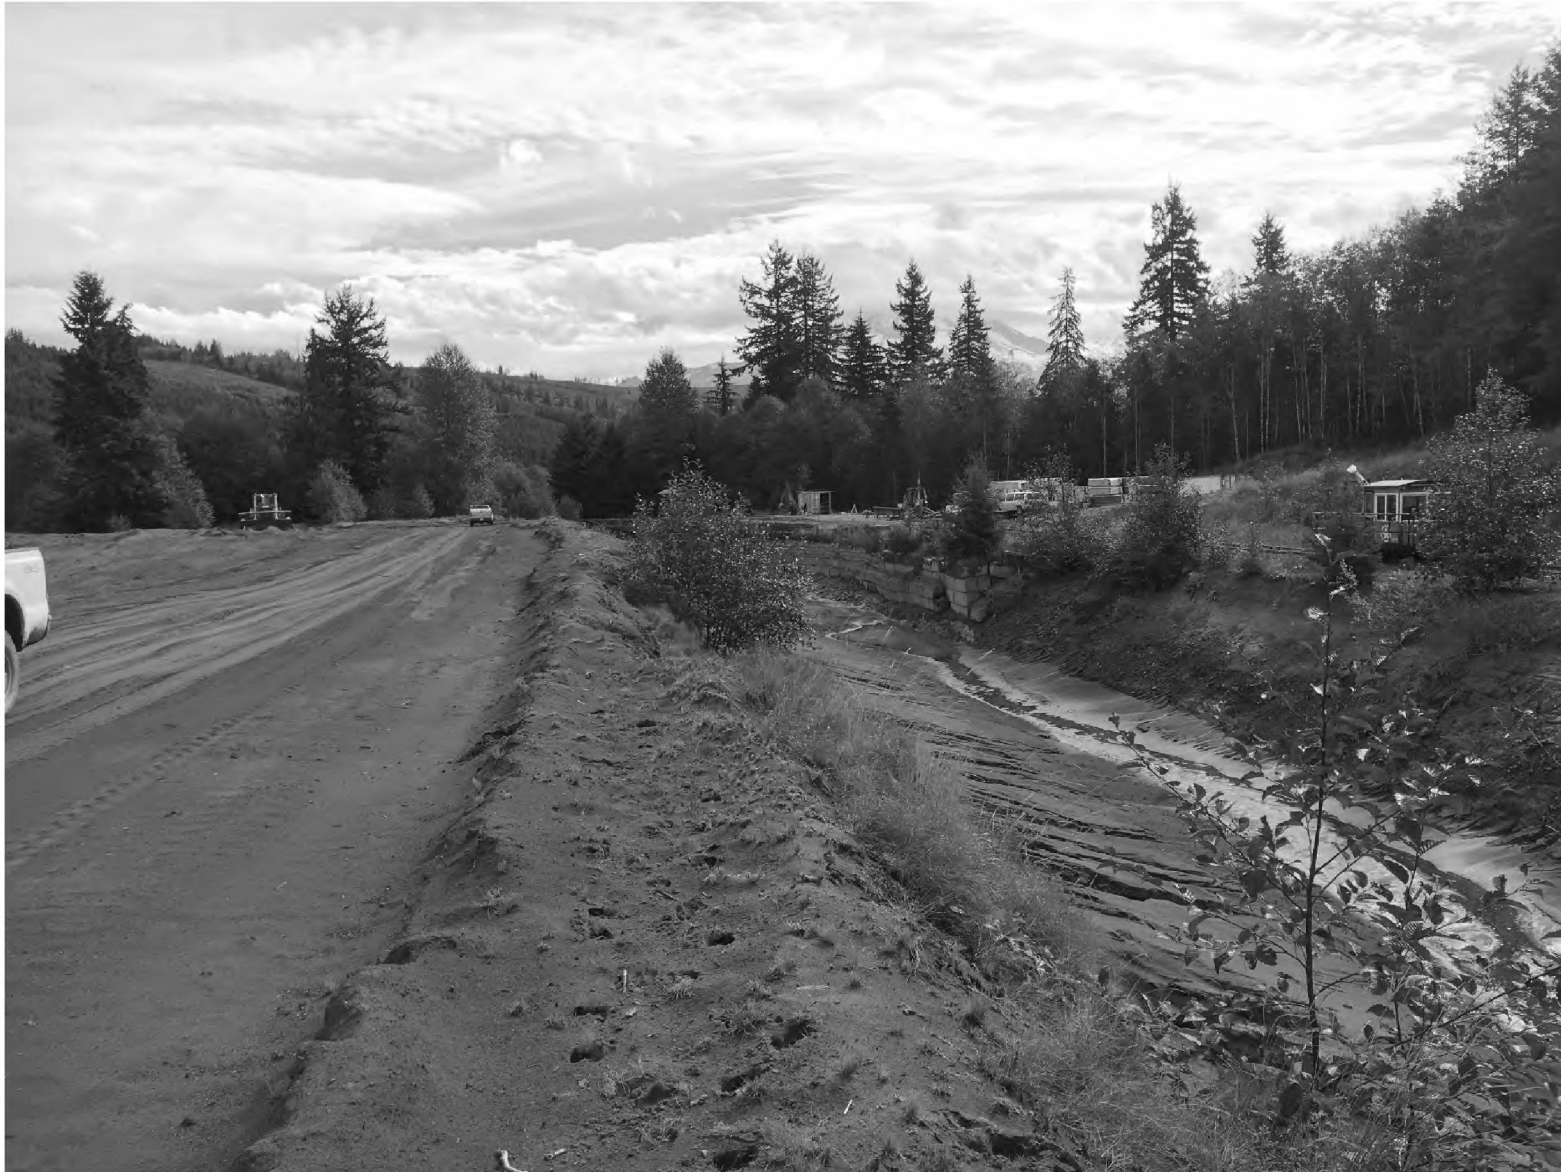
Photo 12

Photo Description: Settling Basin area – small amount of water in the basin from recent rain in bottom of channel, there may be some side slope drainage into basin. Filling area with sediment occurs to left of basin in this photo and beyond.
